Daniels Watershed Agricultural TMDL Implementation Plan

**Developed for the
Idaho Department of Environmental Quality**

**Prepared by
Ben Evans, Steve Smith, Justin W. Krajewski, and Chris Banks
Idaho Soil Conservation Commission
Idaho Association of Soil Conservation Districts**

2007

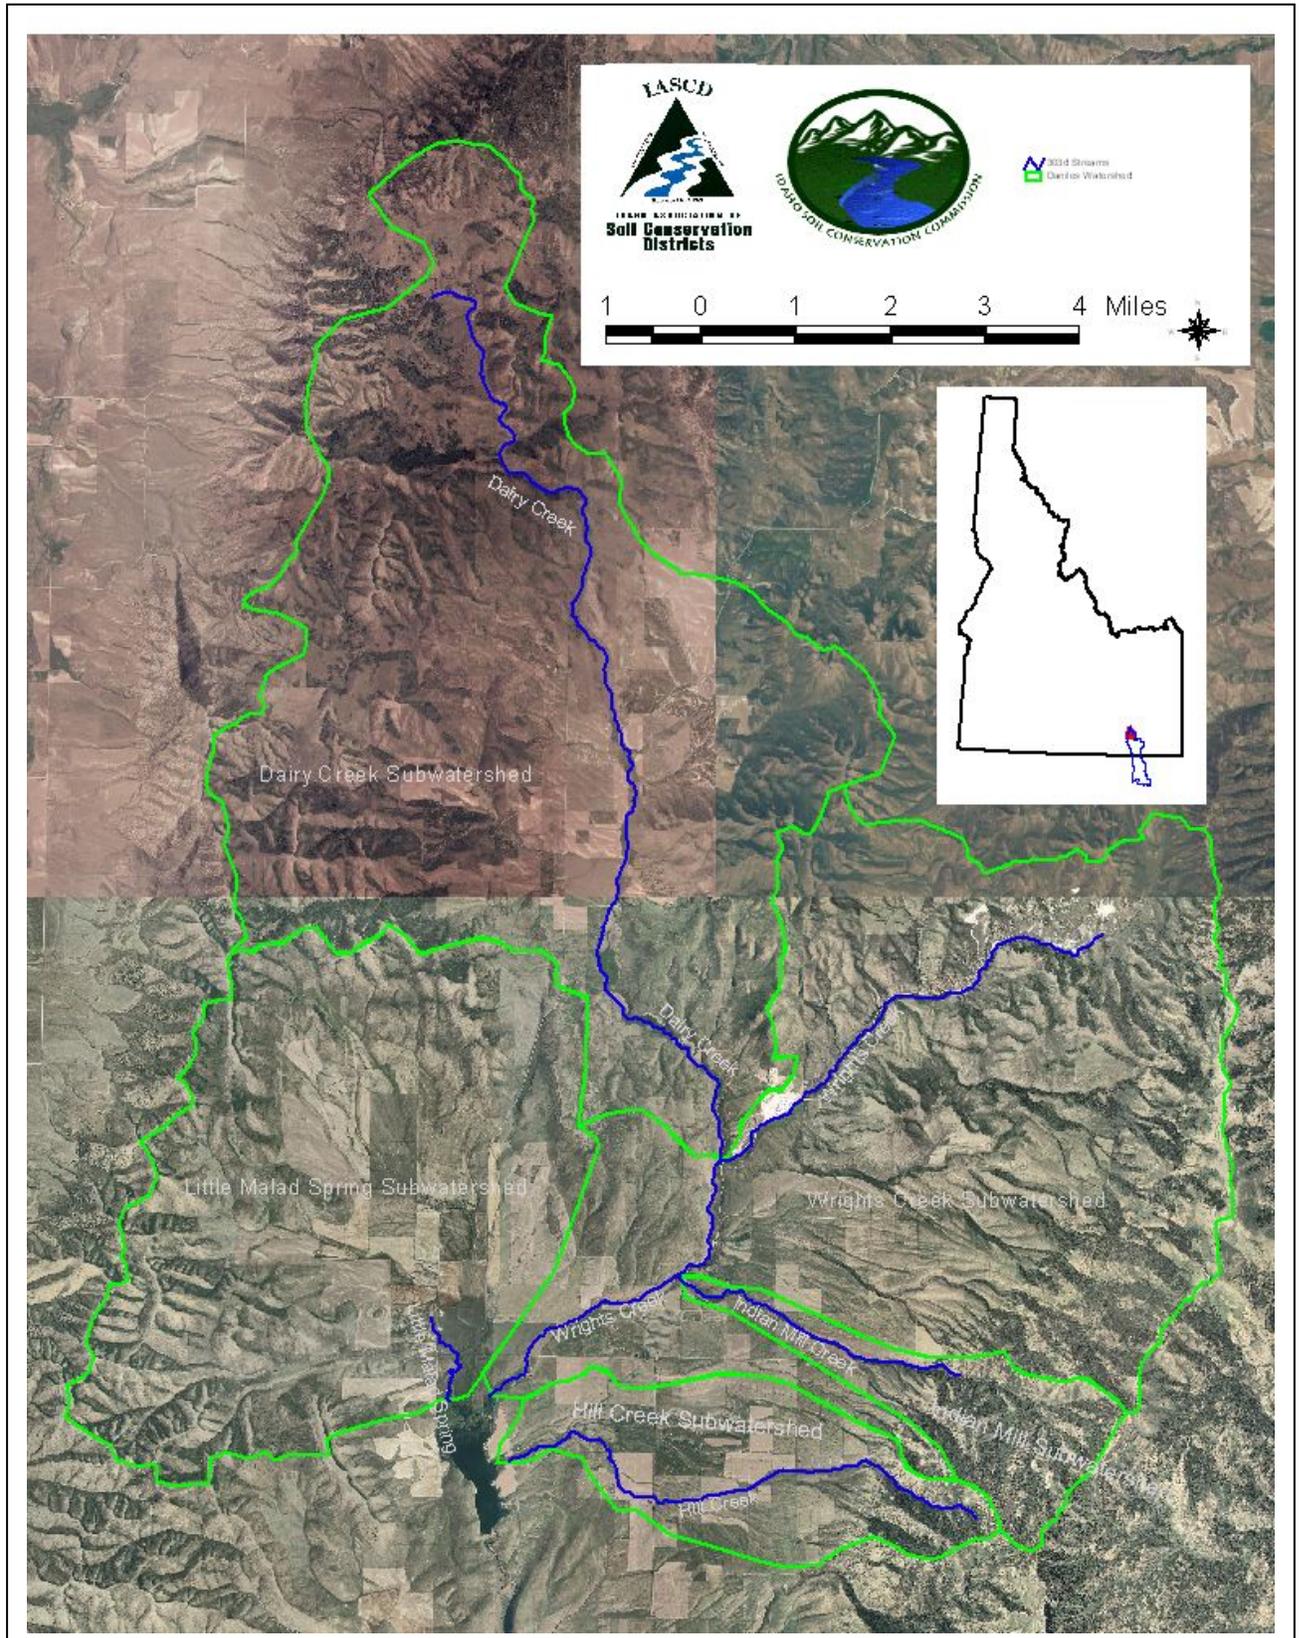
Figure 1. Daniels Watershed in the Lower Bear-Malad Subbasin

The Daniels watershed covers 65,671 acres in the northern portion of the Lower Bear-Malad subbasin. The subwatersheds were delineated based upon the major tributary in the subwatershed for our planning purposes (Figure 1).

The purpose of this plan is to recommend Best Management Practices (BMPs) that would improve or restore physical and biological functions of Wrights Creek, Dairy Creek, Hill Creek, and Little Malad Spring (Figure 1). This plan will build upon past conservation accomplishments made through the Dairy Creek, Wide Hollow, and Daniels State Agriculture Water Quality Program (SAWQP) projects. These past projects and future projects will help to restore beneficial uses in streams in the Daniels watershed. This plan outlines an adaptive management approach for developing conservation plans with private land owners. These conservation plans will recommend how and when BMPs will be installed in critical areas to meet Total Maximum Daily Load (TMDL) targets.

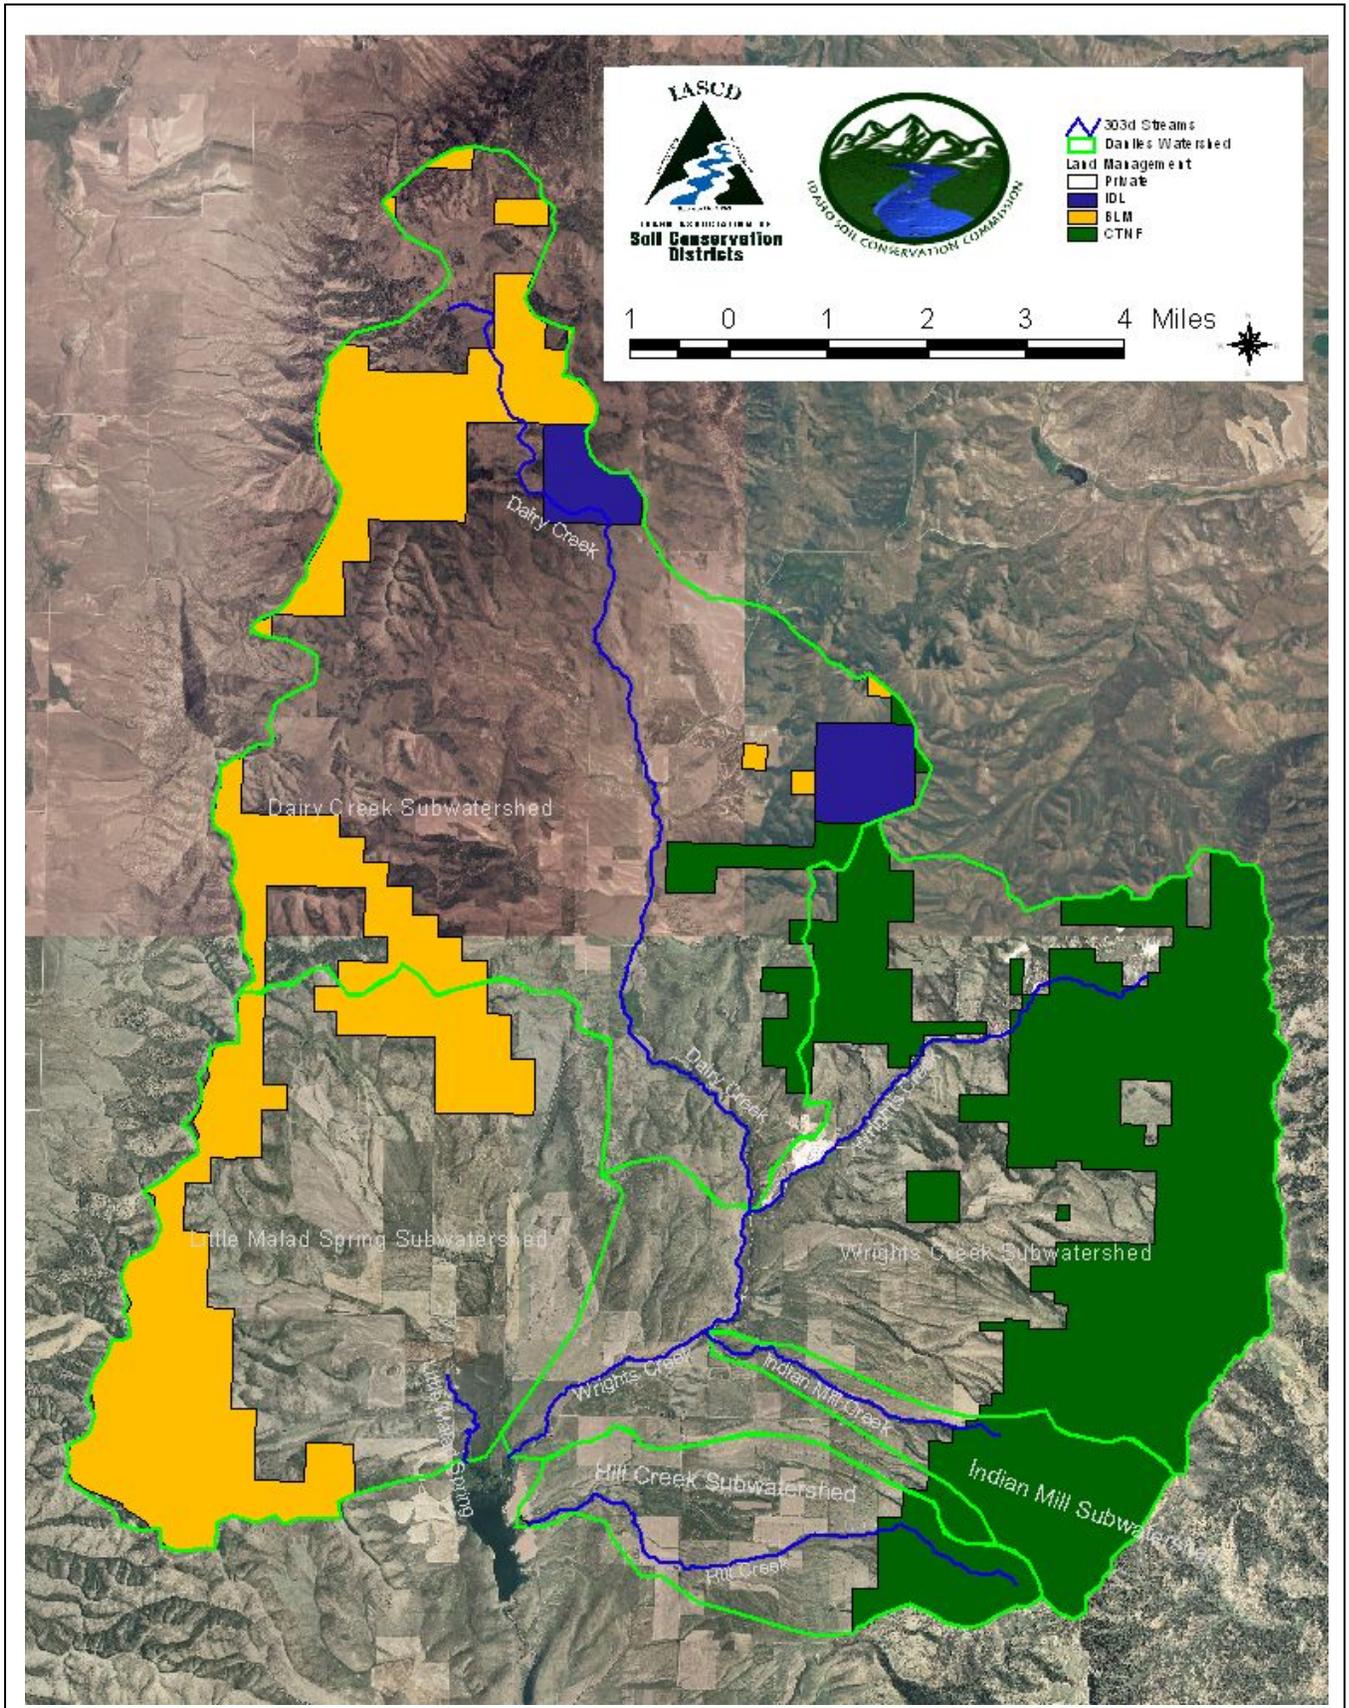
Figure 2. Land Ownership in the Daniels Watershed

Private lands encompass 65% or 42,470 acres of the watershed. In comparison, 35% (23,151 acres) of the watershed are public lands managed by Bureau of Land Management (BLM), Caribou-Targhee National Forest (CTNF), and the Idaho Department of Lands (IDL), shown in Table 1 and Figure 2.

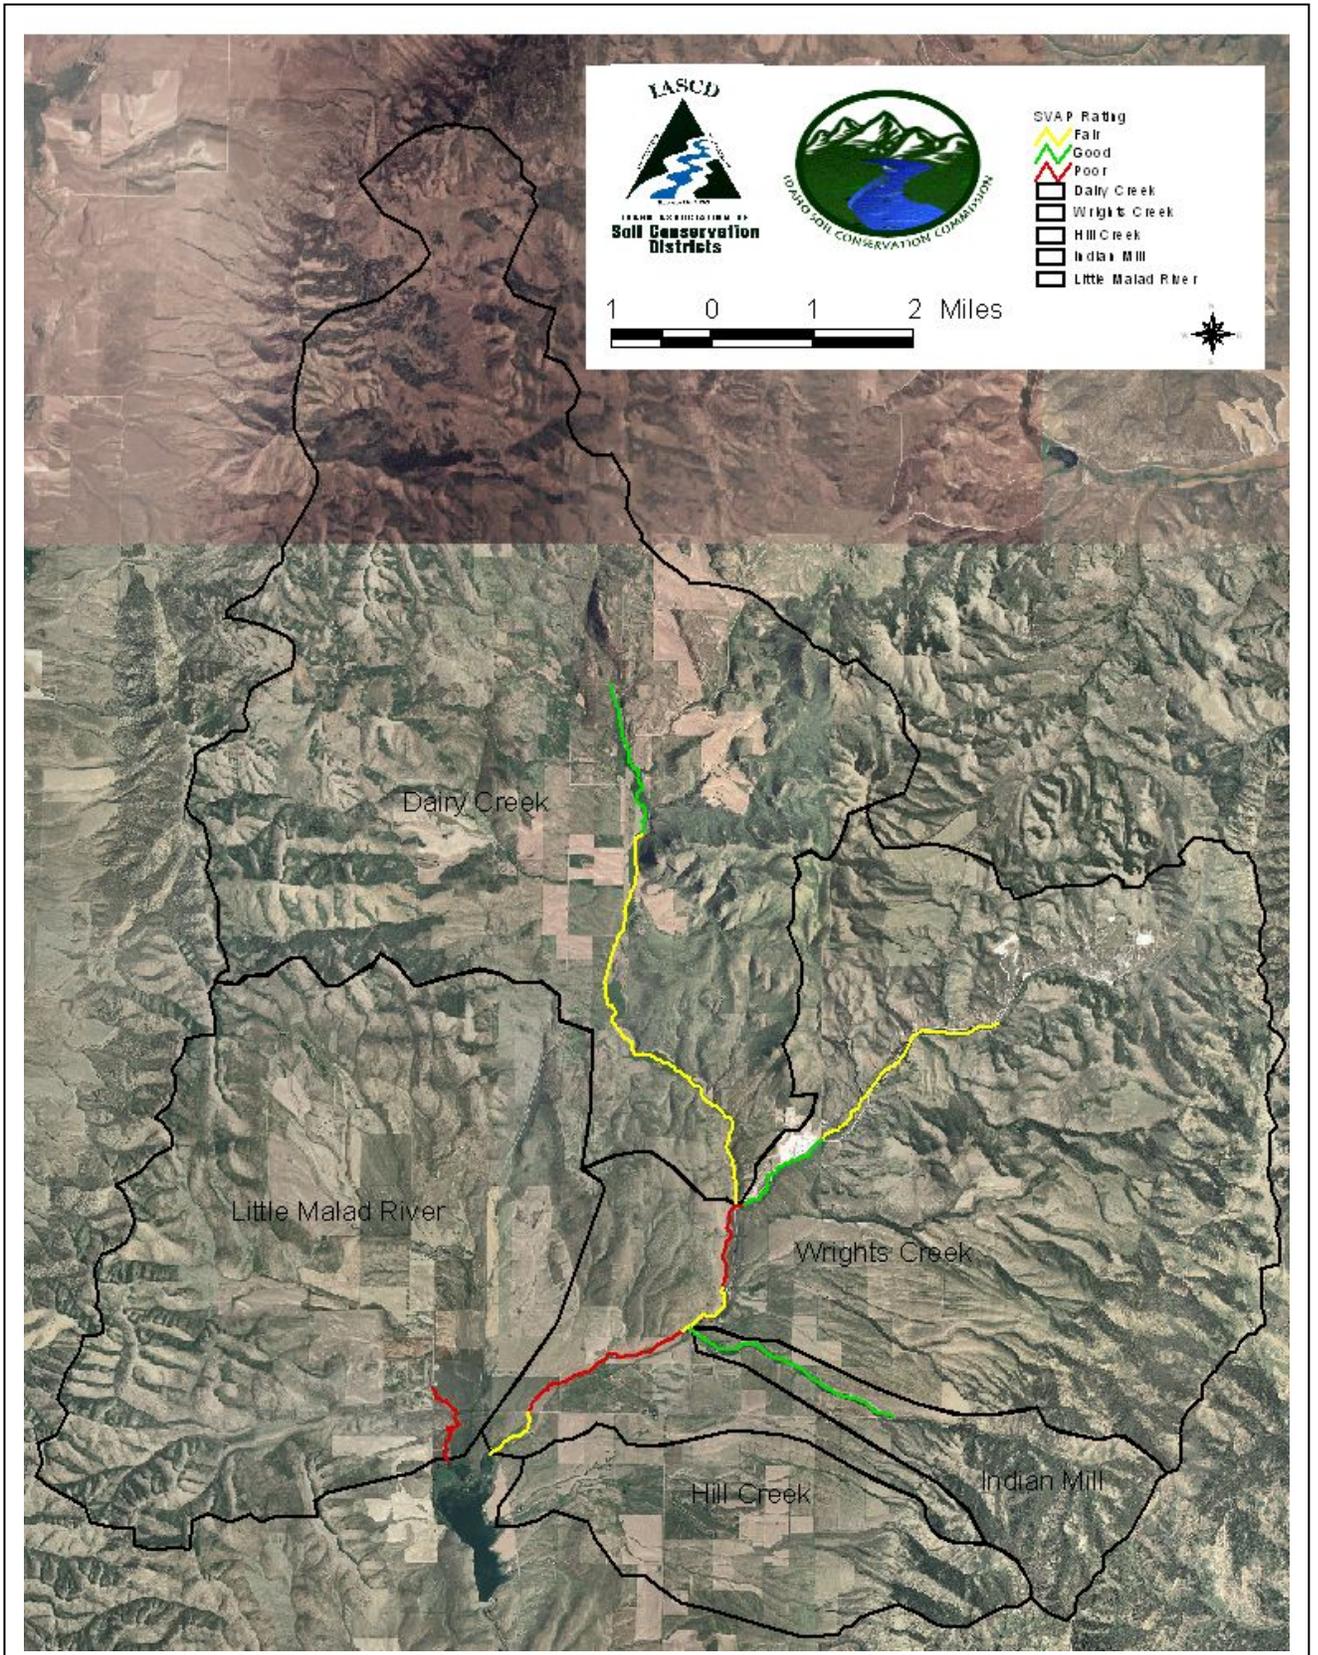
Figure 3. Daniels Watershed Assessed Reaches SVAP Ratings

In 2005, ISCC, IASCD, and NRCS staff used the Stream Visual Assessment Protocol (SVAP) and the Streambank Erosion Condition Inventory (SECI) to assess 23 reaches on 18 miles of Little Malad Spring, Dairy, Wrights, and Indian Mill creeks. They found the majority of reaches had slight streambank erosion, high bank stability, and poor to fair habitat. Those results are shown in Table 6 and Figure 3.

Future implementation efforts should concentrate on four priority reaches, Dairy Creek (DC4) and Wrights (WC7, WC8, & WC11), that have about 75% of the streambank erosion. Another five reaches on Dairy (DC3, DC5, DC6, & DC7) and Little Malad Spring (LM1) Creeks are areas where minor management changes and BMPs could improve water quality and increase aquatic habitat substantially. Eight reaches on Wrights Creek (WC1, WC2, WC 3, WC4, WC9, WC10, WC12 & WC13) had slight to moderate erosion with fair habitat are medium priority because minor management changes with a few structures could improve aquatic habitat, but would take several years to achieve.

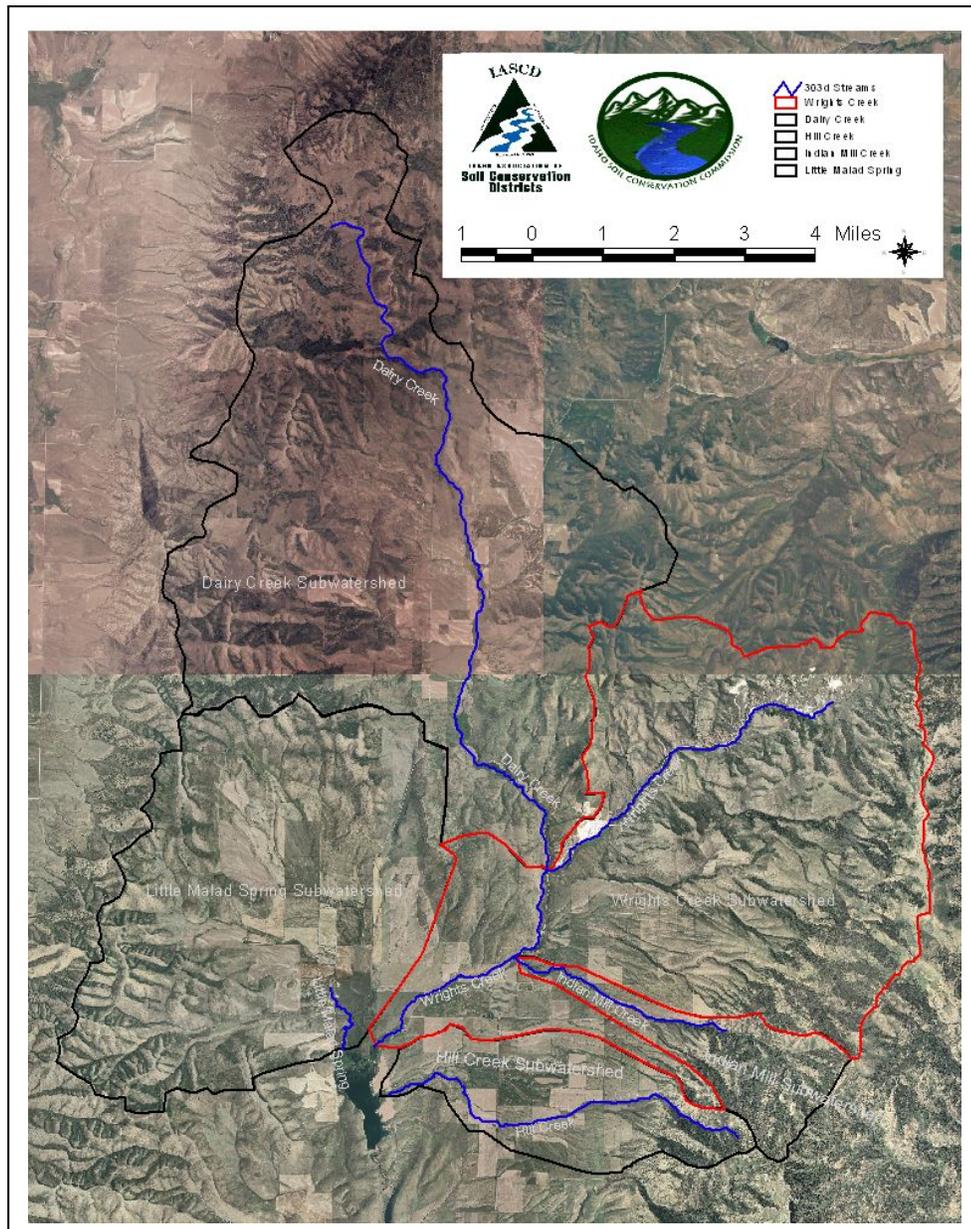
Figure A-1. Wrights Creek Subwatershed in the Daniels Watershed

Wright's Creek subwatershed is bounded on the east by the Bannock Range, to the west by the Deep Creek Range, and to the north by Arbon Valley. Wright's Creek's climate is dry summers followed by cold, moist winters. Most of the precipitation occurs from October to May in the form of snow. Average annual precipitation measures 15 inches at the basin floor to 24 inches in the higher elevations. Elevations range from 9,095 feet to 4,470 feet at the valley floor.

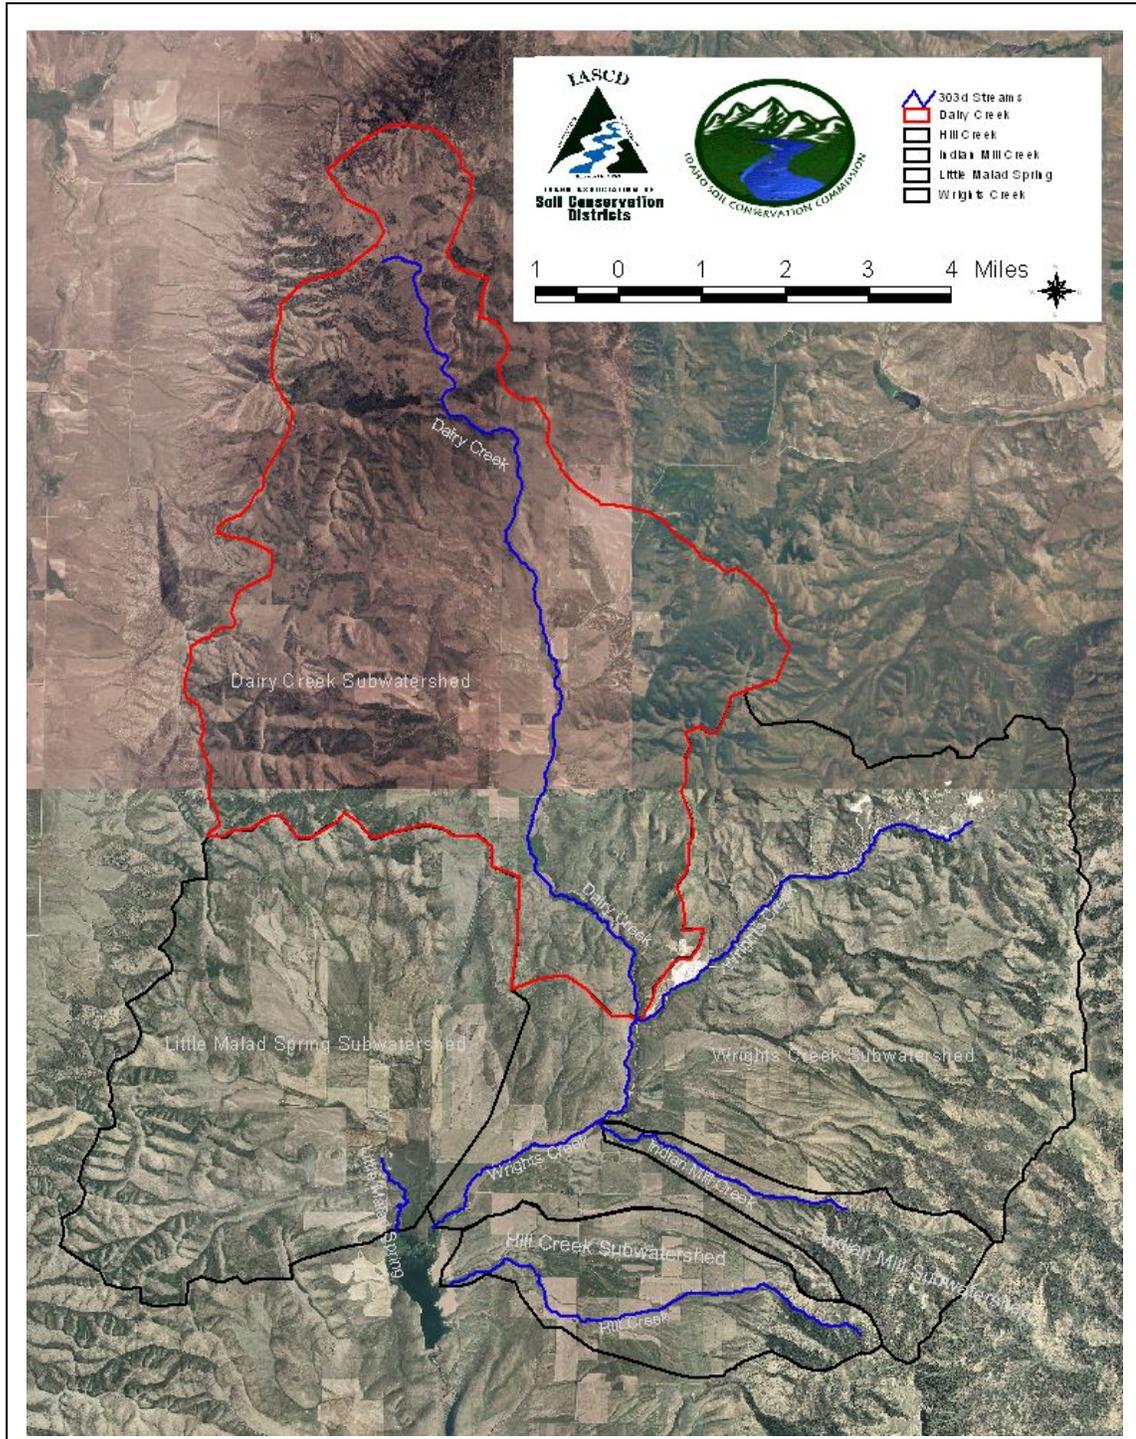
Figure B-1. Dairy Creek Subwatershed in the Daniels Watershed

Dairy Creek subwatershed is bounded by Dry Creek subwatershed to the east, to the west by the Deep Creek Range, to the north by Arbon Valley, and Malad Valley to the south. Dairy Creek's climate is dry summers followed by cold moist winters. Most of the precipitation occurring from October-May comes in the form of snow. Average annual precipitation measures 15 inches at the basin floor to 24 inches in the higher elevations. Elevations range from 6,325 feet to 5,454 feet.

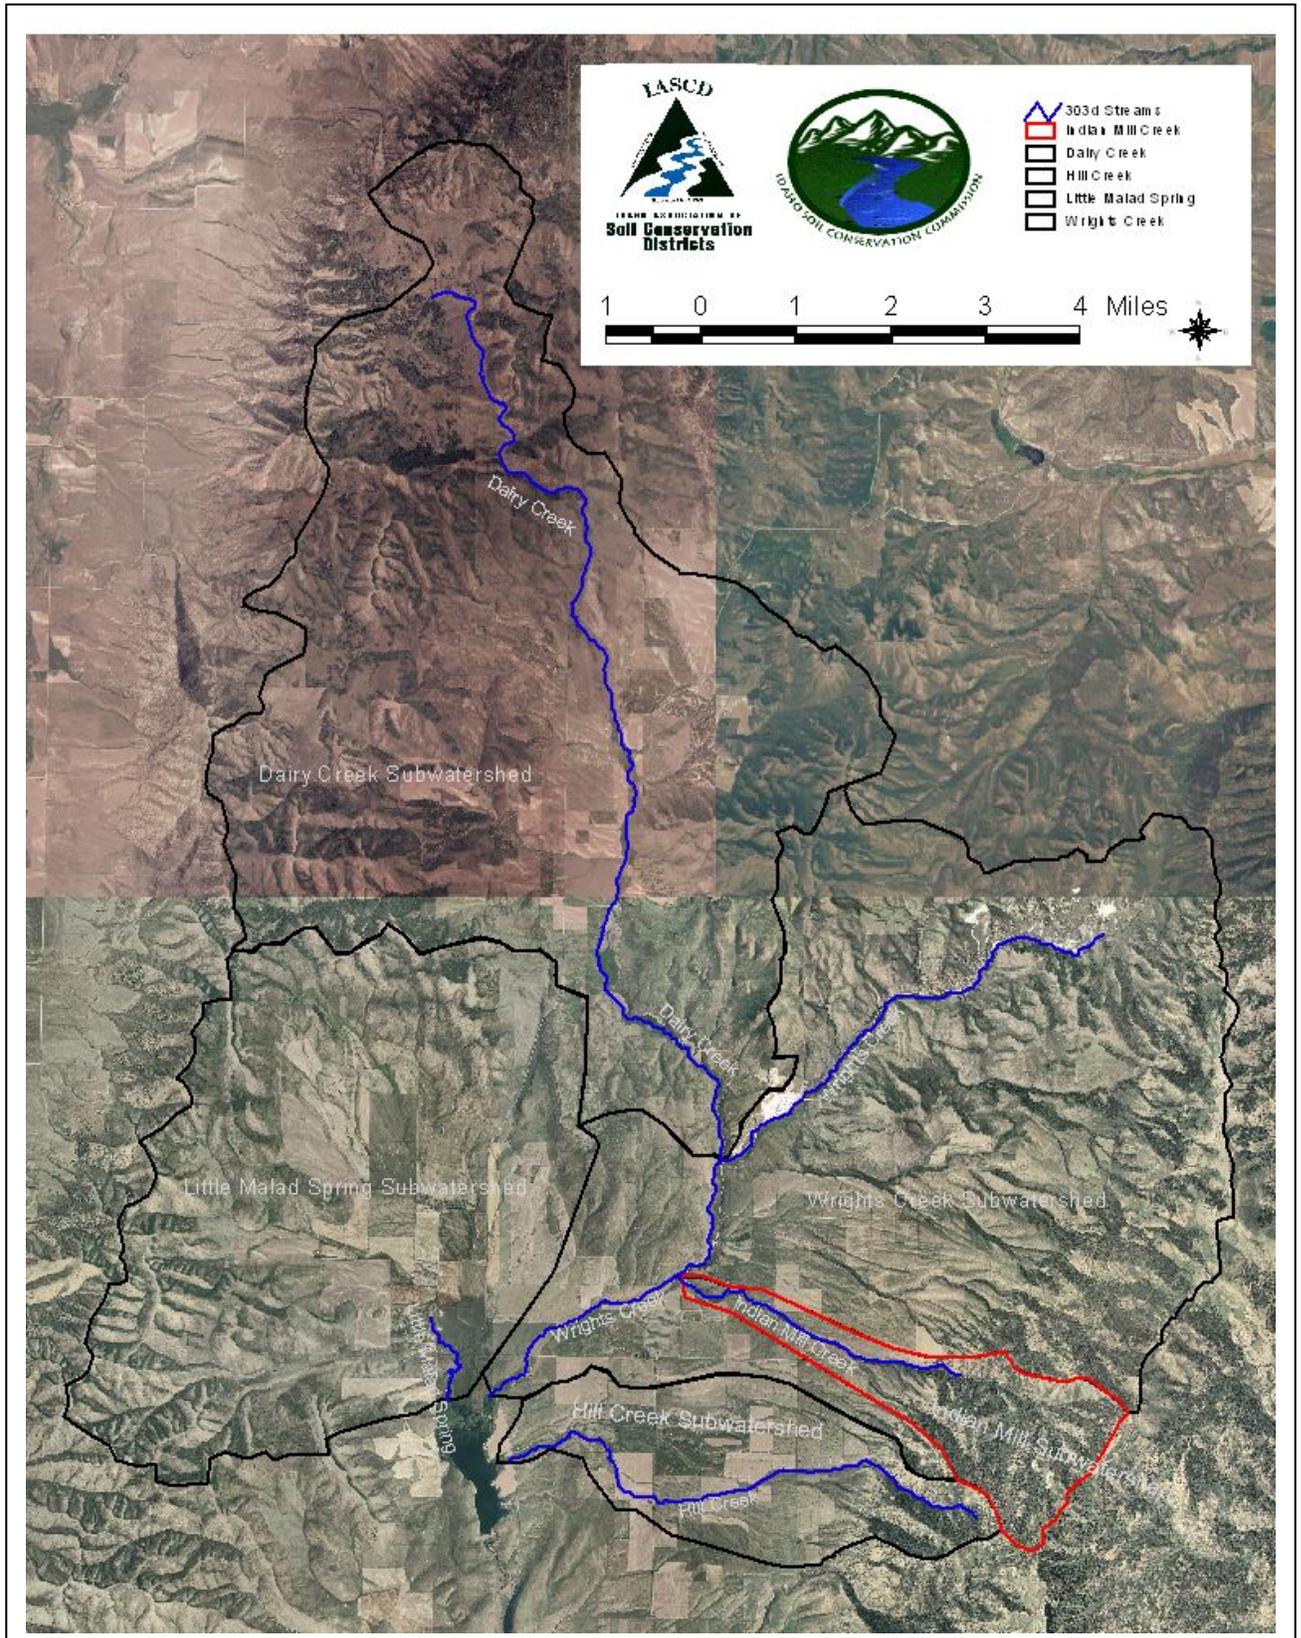
Figure E-1. Indian Mill Creek in the Daniels Watershed

Indian Mill Creek subwatershed is bounded on the east by Bannock Range, to the west by the Deep Creek Range and to the north by Wrights Creek. Indian Mill Creek's climate is dry summers followed by cold, moist winters with most of the precipitation occurring from October to May in the form of snow. Average annual precipitation measures 15 inches at the basin floor to 24 inches in the higher elevations. Elevations range from 8,660 feet to 5,400 feet at the valley floor.
